Failure Analysis of CCD Image Sensors using SQUID and GMR Magnetic Current Imaging

Frederick S. Felt

Failure Analysis Laboratory

NASA Goddard Space Flight Center

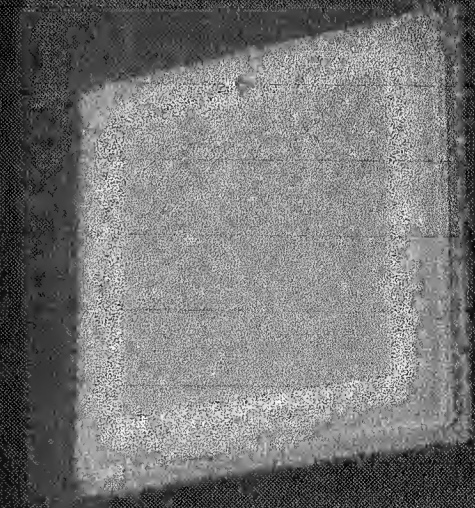
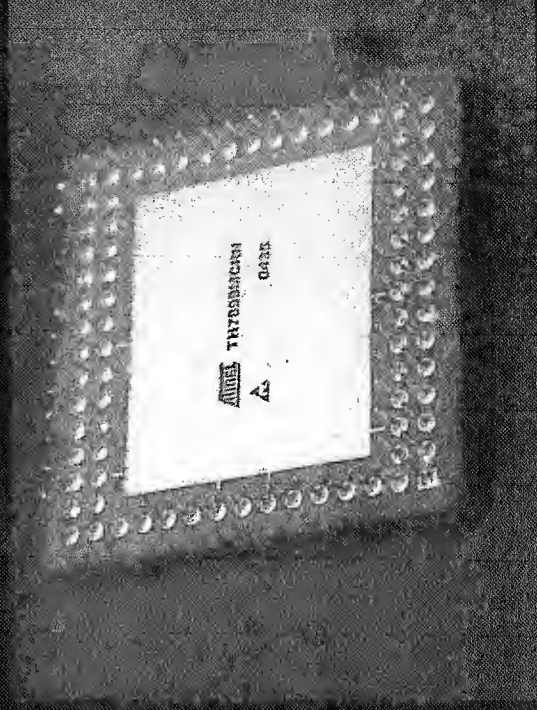
TH7899M CCD Device

- Instrument grade CCD, 14 μ m square pixels
- Fiber optic faceplate covers array
- M2 aluminum light shield over periphery
- Manufacturer: device ESD sensitive to 20V

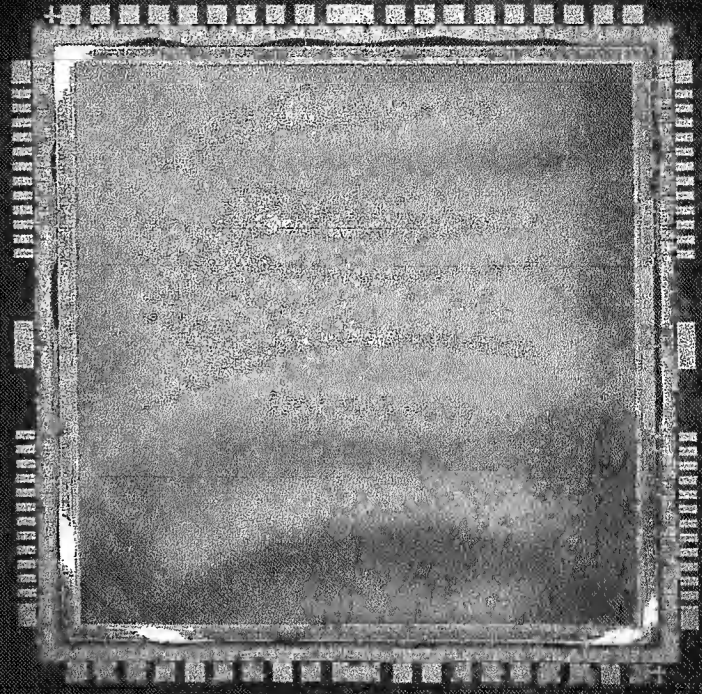
Initial Deprocessing

- Faceplate removed with solvent
- Glue removed by razor/O₂ plasma
- Aluminum light shield over periphery

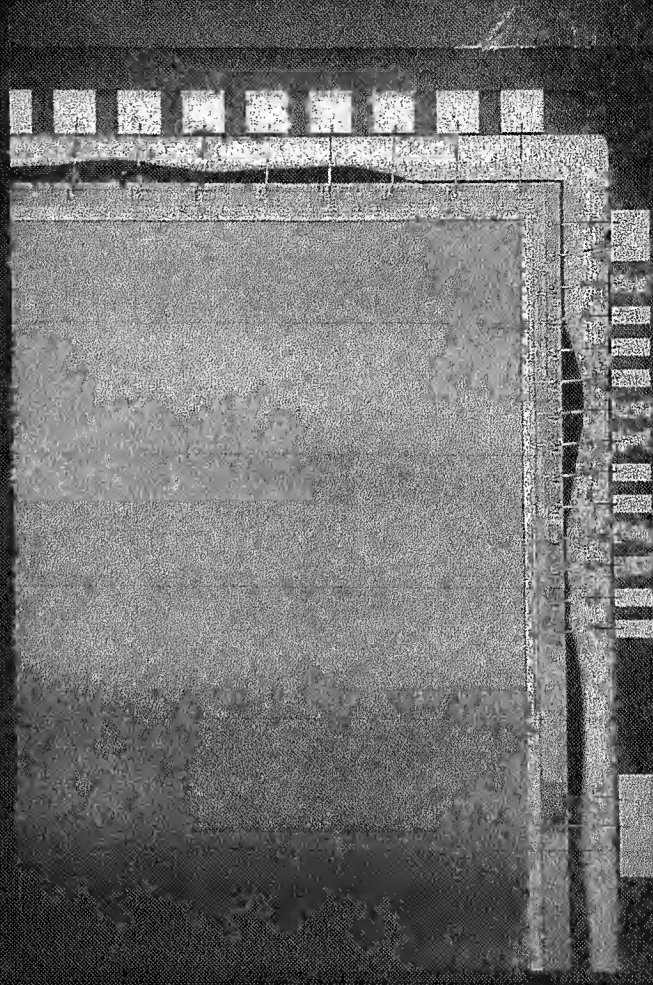
Initial Deprocessing

- Faceplate removed with solvent
- Glue removed by razor/O₂ plasma
- Aluminum light shield noted

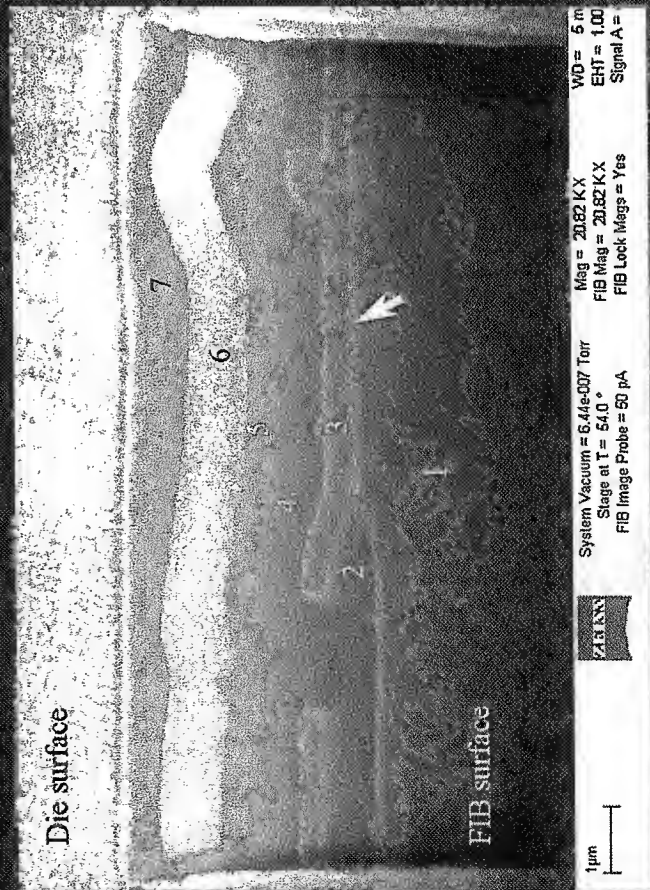
SWA/LA1 short L1

- SN06 FIB cross section
- Evidence of cracking, bridging

- ESD or line transient
- ..with possible secondary damage caused by IR testing
